## **MAIN ROTOR BLADE ABRASION STRIP DAILY INSPECTION REQUIREMENTS**

**Mandatory  
Service Bulletin**

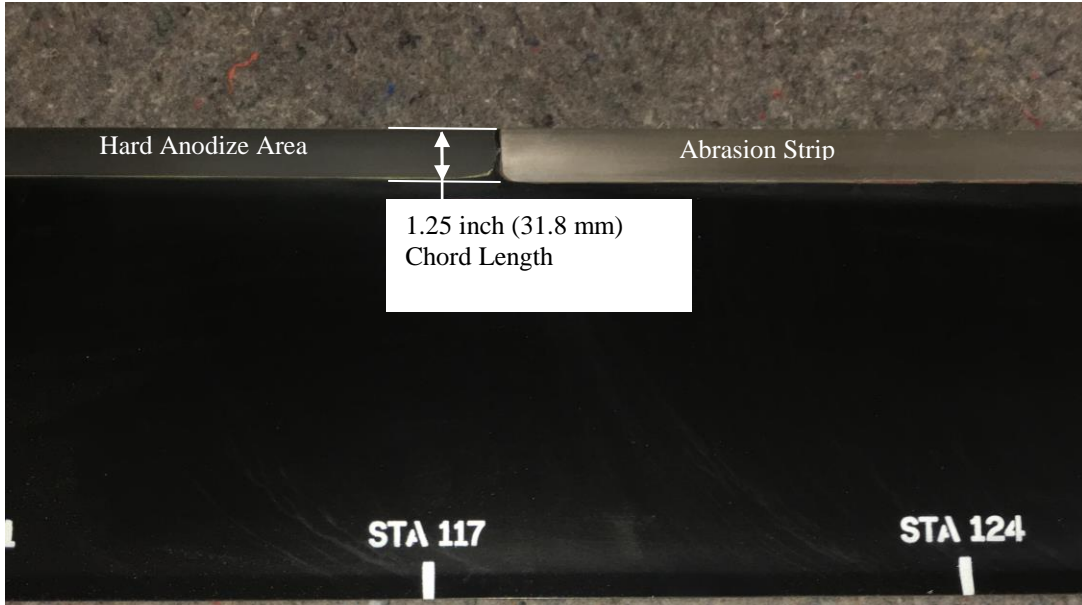
Figure 1 – 1.25 inch (31.8 mm) Chord Abrasion Strip

500P2100-105 (STC Number SR09047RC) with 1.25 inch (31.8 mm) Chord Length Abrasion Strip installed and less than 700 hours Total Time Since New (TTSN) or since Abrasion Strip Replacement, All Serial Numbers. These blades are also known as MD Helicopters, Inc. Part Number 369D21120-505 and all references in MD Helicopters, Inc. CSP-HMI-2 that pertain to Part Number 369D21120-505 pertain to HTC Part Number 500P2100-105 as well.

- 1) Determine which Chord Length Abrasion Strip is present on the subject blade and Total Time Since New (TTSN) or since Abrasion Strip Replacement to determine if this Mandatory Service Bulletin is applicable. Reference **Figure 1** and **Figure 2** on Page 2.

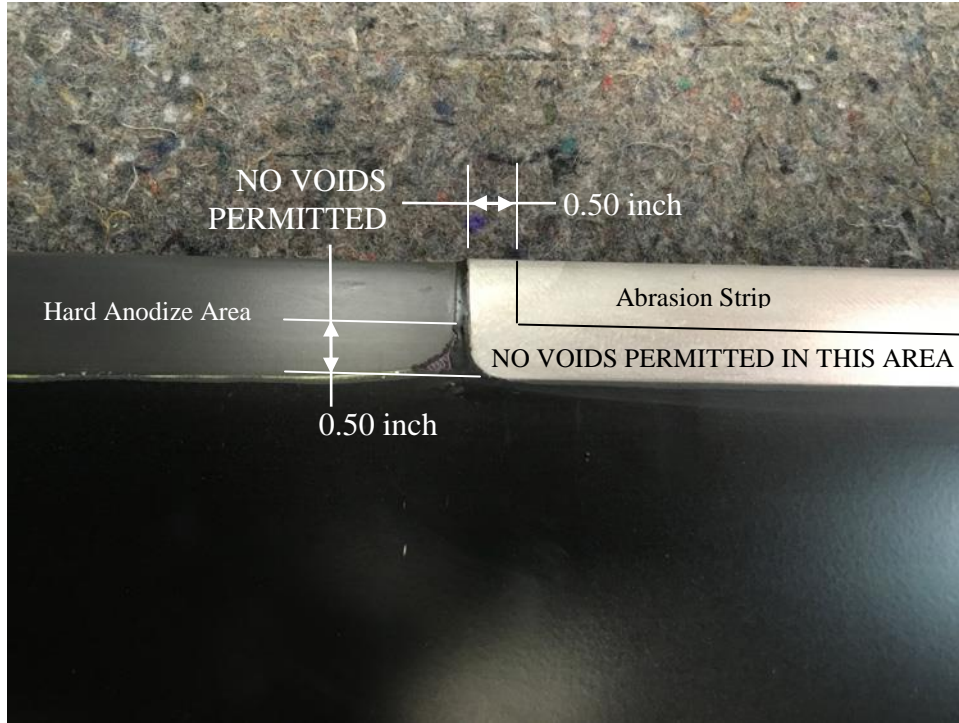
Figure 3 – Inboard Abrasion Strip Area

- 2) The leading edge Abrasion Strip shall be inspected for Voids, including Blistering, Bubbling, or Lifting on Every Daily Inspection by Tap Testing.

- 4) A Void will produce a tone change. The tone will be lower over the Void. A method of “tuning” your ear is to tap from the leading edge of the blade towards the trailing edge. As you move past the aft edge of the spar and over the unsupported skin, you will notice a distinctive lowering of the tone produced.

- 5) If any Void is found within 0.50 inches (12.7 mm) of any edge regardless of size, replace the subject blade with another airworthy blade, Reference **Figure 3** and **Figure 4** on Page 5. **Note: Do not attempt a field repair.**

- 7) If multiple Voids are present or a Void exceeds 0.50 square inches (322.6 square mm), replace the subject blade with another airworthy blade. **Note: Do not attempt a field repair.**
