**Mandatory
Service Bulletin**

**MAIN ROTOR BLADE ABRASION STRIP
DAILY INSPECTION REQUIREMENTS**

MD Helicopters, Inc. Models 369A, H, HE, HM, HS, D, E, FF, 500N, and 600N.

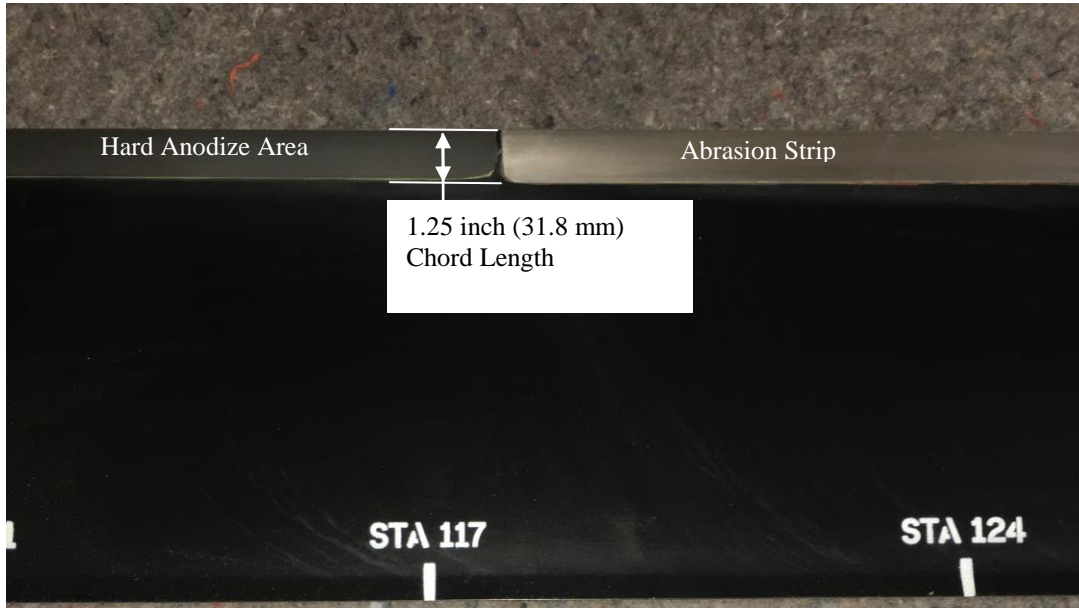
Figure 1 – 1.25 inch (31.8 mm) Chord Abrasion Strip

Subject
to this
Mandatory
Service
Bulletin

- 1) Determine which Chord Length Abrasion Strip is present on the subject blade and Total Time Since New (TTSN) or since Abrasion Strip Replacement to determine if this Mandatory Service Bulletin is applicable. Reference **Figure 1** and **Figure 2** on Page 2.

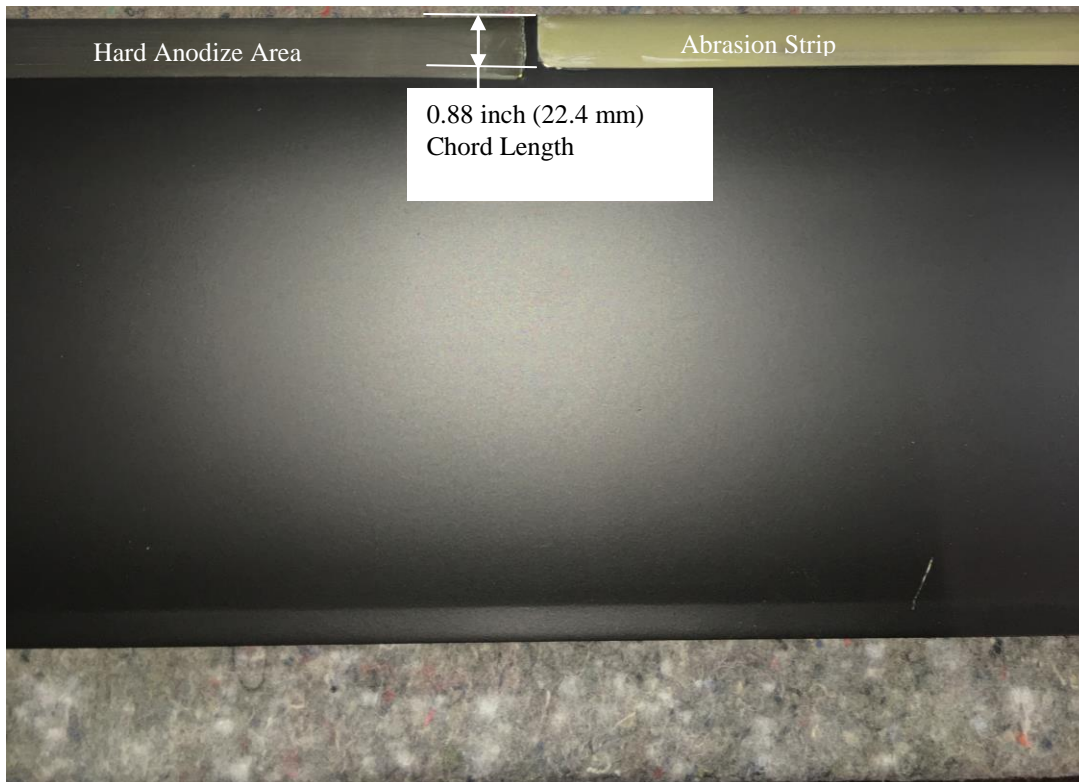
Figure 2 – 0.88 inch (22.4 mm) Chord Abrasion Strip

Not
Subject
to this
Mandatory
Service
Bulletin

- 1) If applicable, Fielded Main Rotor Blades are to be returned to the HTC Factory or an HTC Authorized Repair Station qualified to perform this modification. This modification consists of the removal and replacement of the Abrasion Strip with a 0.88 inch (22.4 mm) chord Stainless Steel Abrasion Strip in accordance with HTCQ-004, Revision I (or later approved revision) Standard Repair Instruction – Main Rotor Blade. Installation of the 0.88 inch (22.4 mm) chord Stainless Steel Abrasion Strip shall constitute compliance and repeating **PART 1** is no longer required.

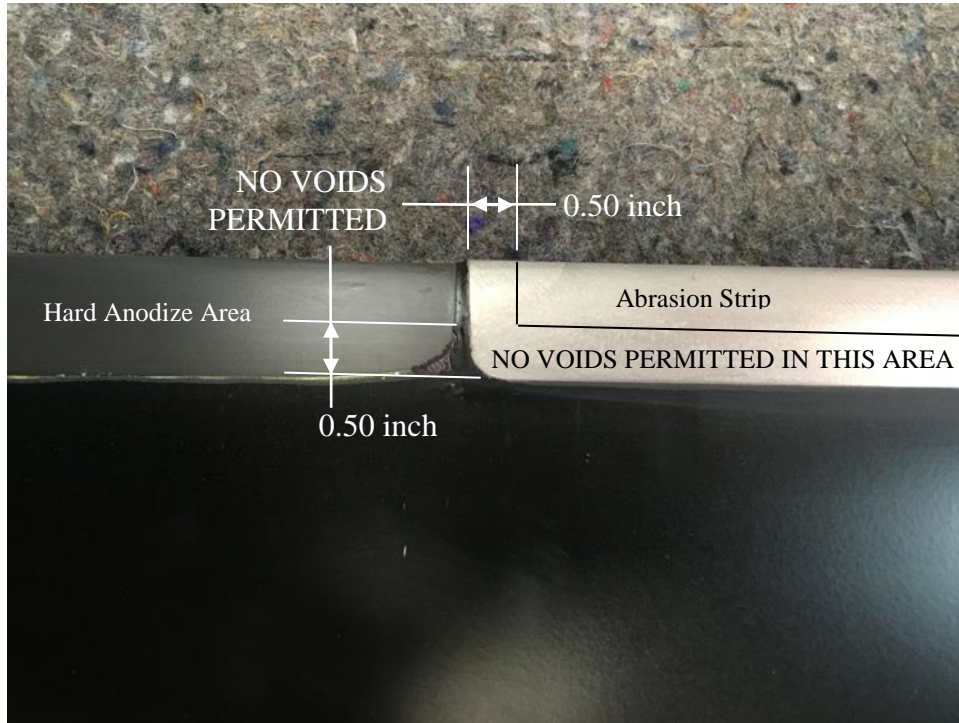
Figure 3 – Inboard Abrasion Strip Area

- 5) If any Void is found within 0.50 inches (12.7 mm) of any edge regardless of size, replace the subject blade with another airworthy blade, Reference **Figure 3** and **Figure 4** on Page 5. **Note: Do not attempt a field repair.**
