**Mandatory  
Service Bulletin**

**MAIN ROTOR BLADE  
ENHANCED 100-HOUR INSPECTION REQUIREMENTS**

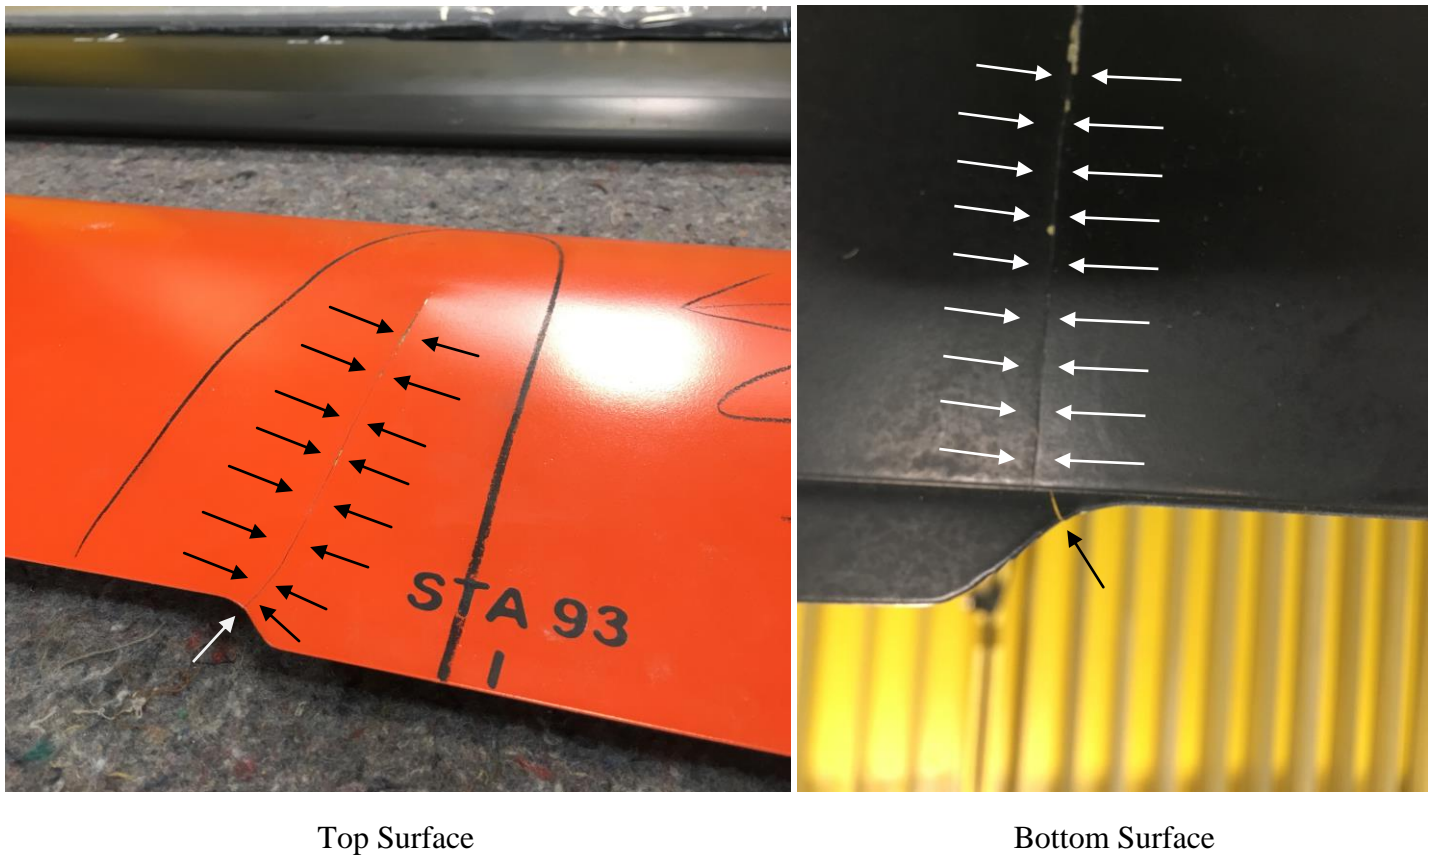
Two operators of MD Helicopters, Inc. Model 369/500/600 Helicopters experienced cracking in the Skin adjacent to the Trim Tab on one of their Main Rotor Blades. In both cases, the cracking was discovered during inspection after completing a flight during which an increase in vibration levels was noticed.

Evidence of damage in the affected area due to impact damage, filing, or sanding was present under the paint.

Examples of Cracking adjacent to the Inboardmost Area of the Trim Tab (Approximately Blade Station 91) Initiating at the Trailing Edge and Proceeding in the Leading Edge Direction

- 1) Perform Inspection required for Area 8 as defined in CSP-HMI-2, Chapter 62-10-00 and in CSP-H-2, Section 7, Chapter 10, as applicable.
- 2) Additionally, Inspect each subject Main Rotor Blade for Cracking adjacent to the Inboardmost Area of the Trim Tab (Approximately Blade Station 91, Area 8 as defined in Figure 601 in CSP-HMI-2, Chapter 62-10-00 and Figure 7-8 in CSP-H-2, Section 7, Chapter 10) initiating at the Trailing Edge and proceeding in the Leading Edge direction. Inspect the Top Surface and Bottom Surface independently. Use a **Bright Flashlight** and **10x Magnifying Glass**. Any evidence of cracking scraps the blade. See **Figure 1** for examples of Cracking.
- 3) If a crack is found, replace Blade with an airworthy Main Rotor Blade.
