**Mandatory
Service Bulletin**

**MAIN ROTOR BLADE
ENHANCED 100-HOUR INSPECTION REQUIREMENTS**

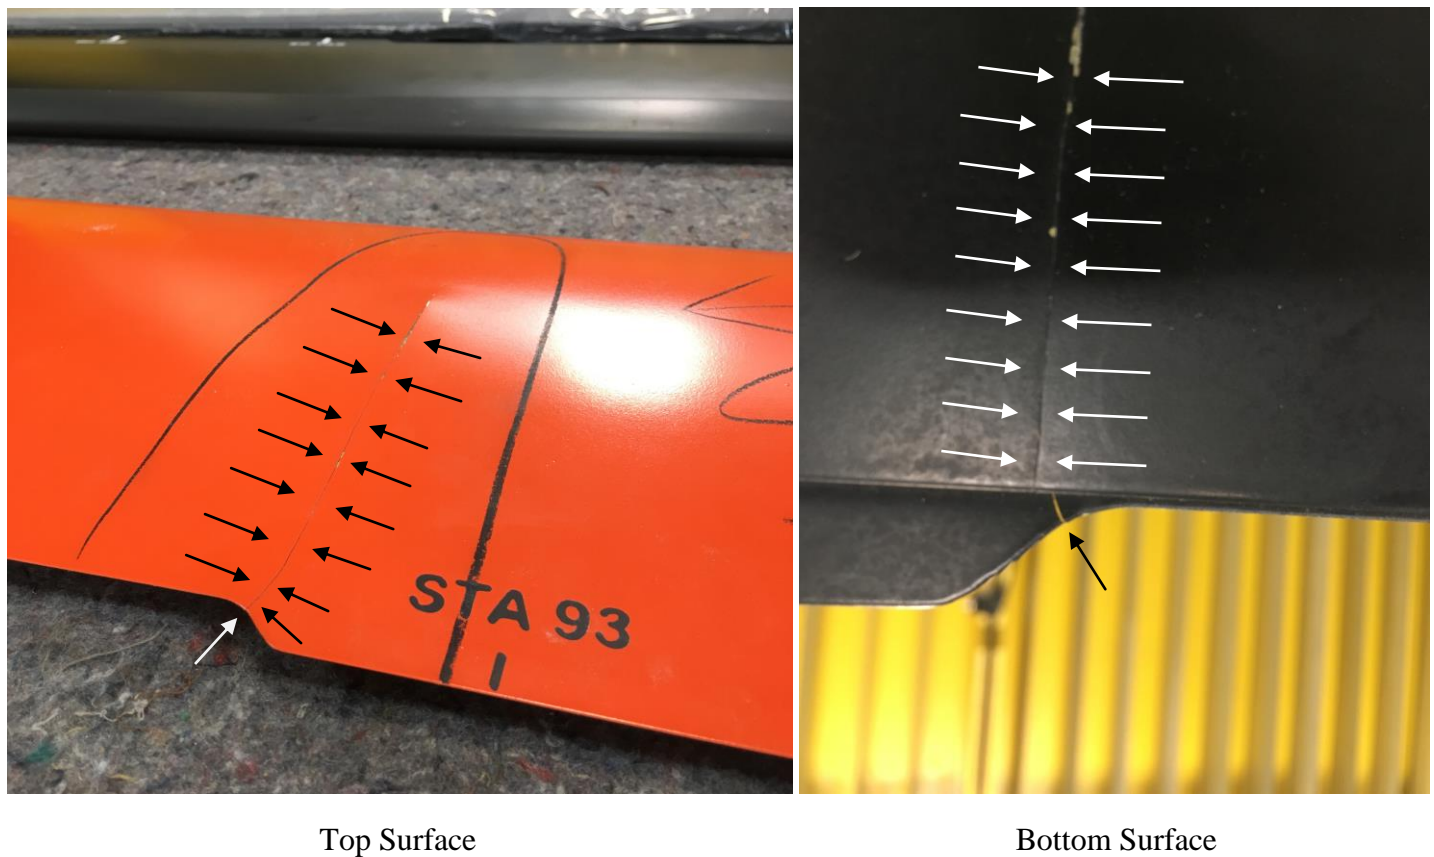
Figure 1

Two operators of MD Helicopters, Inc. Model 369/500/600 Helicopters experienced cracking in the Skin adjacent to the Trim Tab on one of their Main Rotor Blades. In both cases, the cracking was discovered during inspection after completing a flight during which an increase in vibration levels was noticed.

Evidence of damage in the affected area due to impact damage, filing, or sanding was present under the paint.

Examples of Cracking adjacent to the Inboardmost Area of the Trim Tab (Approximately Blade Station 91) Initiating at the Trailing Edge and Proceeding in the Leading Edge Direction

- 1) Perform Inspection required for Area 8 as defined in CSP-HMI-2, Chapter 62-10-00 and in CSP-H-2, Section 7, Chapter 10, as applicable.
- 2) Additionally, Inspect each subject Main Rotor Blade for Cracking adjacent to the Inboardmost Area of the Trim Tab (Approximately Blade Station 91, Area 8 as defined in Figure 601 in CSP-HMI-2, Chapter 62-10-00 and Figure 7-8 in CSP-H-2, Section 7, Chapter 10) initiating at the Trailing Edge and proceeding in the Leading Edge direction. Inspect the Top Surface and Bottom Surface independently. Use a **Bright Flashlight** and **10x Magnifying Glass**. Any evidence of cracking scraps the blade. See **Figure 1** for examples of Cracking.
- 3) If a crack is found, replace Blade with an airworthy Main Rotor Blade.
