EMERGENCY AIRWORTHINESS DIRECTIVE

**Federal Aviation
Administration**

AD #: 2003-08-51

2003-08-51 MD HELICOPTERS, INC.: Docket No 2003-SW-17-AD.

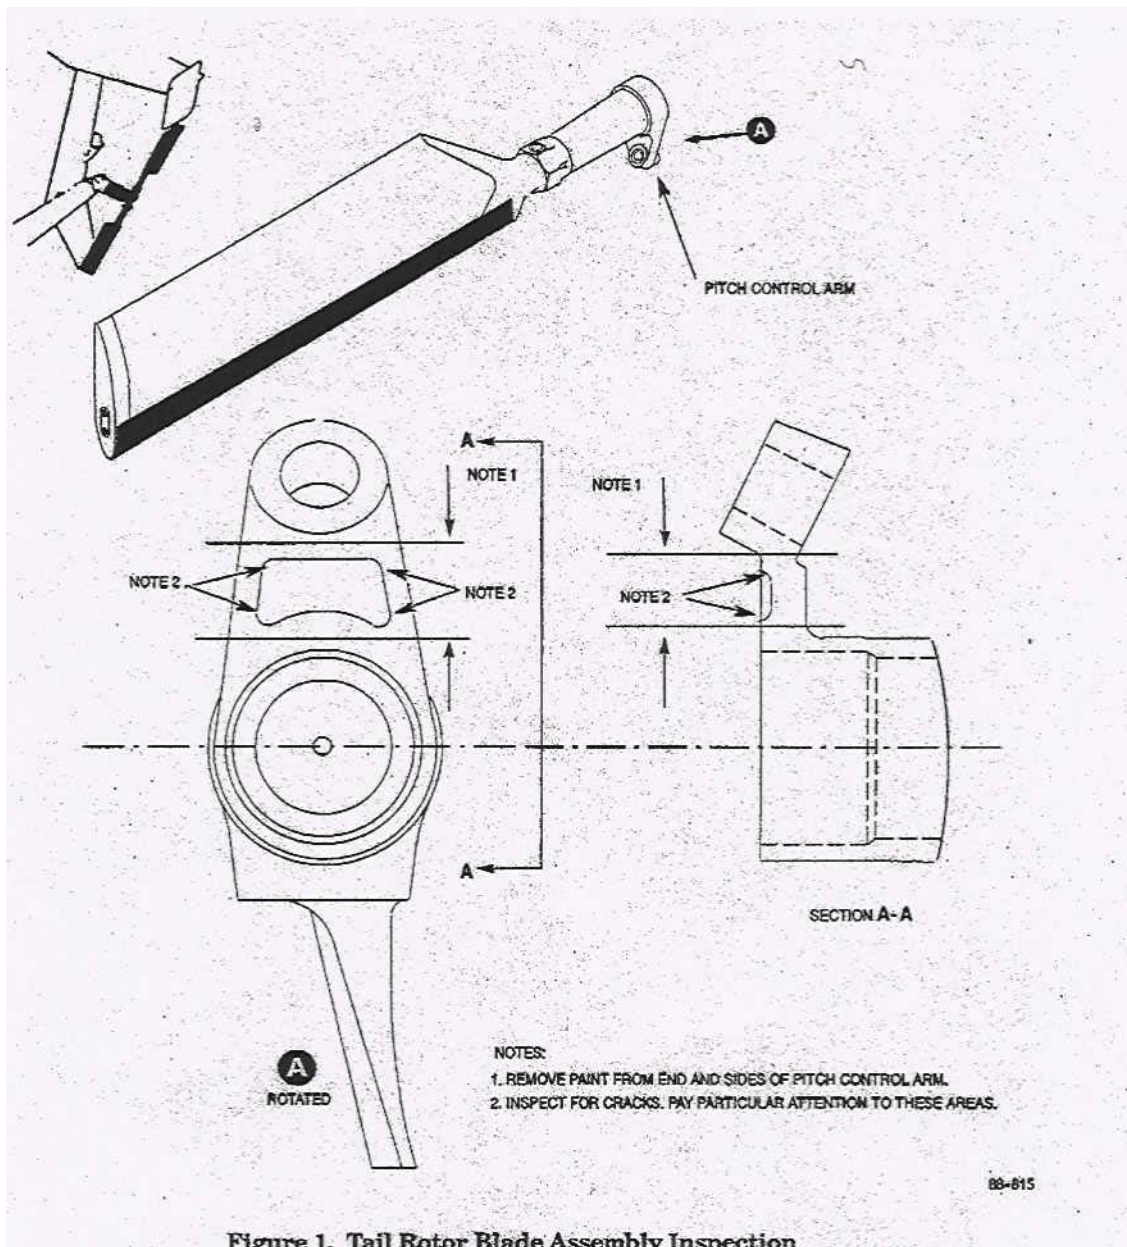
This Emergency Airworthiness Directive (EAD) is prompted by two reports of cracked tail rotor blade pitch horns (pitch horns) that failed during flight. In both occurrences, the pilot was able to land the helicopter without further incident. Investigation revealed that the cause of the failures was a fatigue crack in the pitch horns that developed before the tail rotor blade reached its retirement life. This condition, if not corrected, could result in a pitch horn separating from the tail rotor blade leading to an unbalanced condition, vibration, loss of tail rotor pitch control, and loss of directional control of the helicopter.

(b) Before further flight, perform a one-time visual inspection of each pitch horn for a crack or corrosion in the area indicated by Note 2 in Figure 1 of this AD. Paint removal in accordance with Note 1 of Figure 1 of this AD is not required for the visual inspection.

(d) For helicopters with a tail rotor blade installed that has more than 700 hours TIS, a one-time special flight permit to fly it to a repair facility may be issued only upon completion of an eddy current surface scan of each affected pitch horn (see Figure 1 of this AD). Paint removal in accordance with Note 1 of the Figure 1 of this AD **IS** required for the surface scan. If a crack is found, remove the tail rotor blade and replace it with an airworthy tail rotor blade before further flight.
