## **INSPECTION OF MAIN ROTOR BLADE**

**Mandatory  
Service Bulletin**

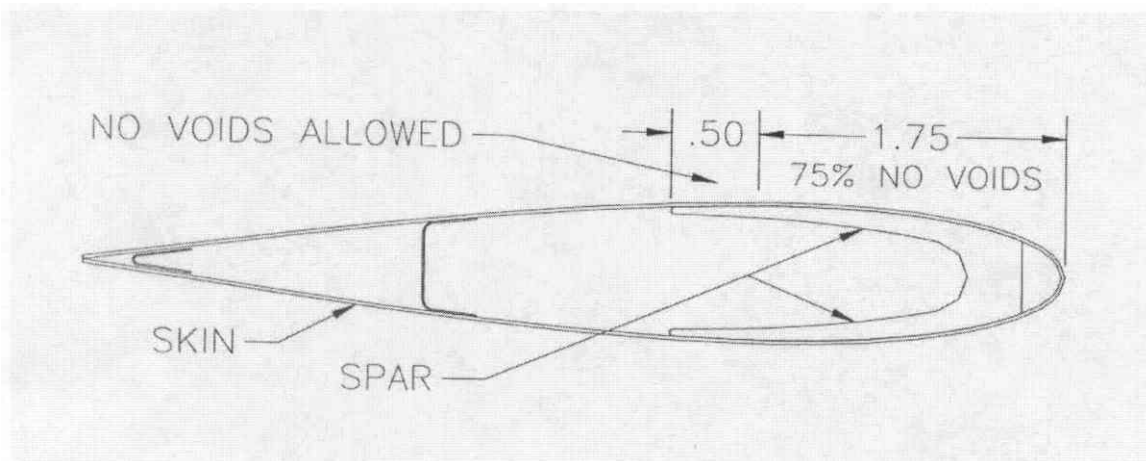
The tap inspection may be conducted using a coin (U.S. 25 cent piece or equivalent) or a small brass, steel, or aluminum hammer. Lightly tap the area over the spar as shown in the sketch below. A void will produce a tone change. The tone will be lower over the void. A method of "tuning" your ear is to tap from the leading edge of the blade towards the trailing edge. As you move pass the aft edge of the spar and over the unsupported skin, you will notice a distinctive lowering of the tone produced. Tap in a pattern with no more than 0.50 inches between taps in any direction.
