**Mandatory  
Service Bulletin**

**MAIN ROTOR BLADE CORROSION INSPECTION AND PROTECTION**

500P2100-BSC and -BSC-1 (STC Number: SR09172RC), All Serial numbers.

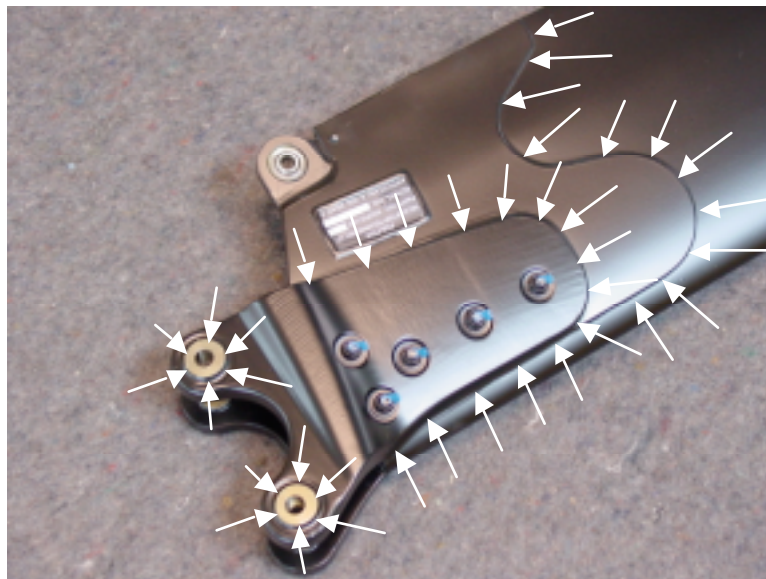
Figure 1 – Main Rotor Blade Root End Affected Areas (Bottom Side Shown – Same Applies to Top Side)

- 2) Inspect areas as shown in Figure 1 and Figure 2 for Active Corrosion. Any evidence of corrosion in these areas is cause for scrapping of the blade.

- 3) If areas do not have Sealant in place, apply small bead of Sealant around peripheries (top and bottom surfaces) of Root Fitting Bushings (inside and outside), around peripheries of Root Fitting-to-Doubler Bond-Lines, around peripheries of Doubler-to-Skin Bond-Lines, around Abrasion Strip-to-Skin Bond Lines, and around the Tip End of the Blade as shown in Figure 1 and Figure 2 below. Ensure that the center portion of each of the Tip Cap Rivets (2 Places, Top and Bottom Side of Blade – Figure 2) are sealed to prevent water/moisture from entering the blade.
