## **MAIN ROTOR BLADE DRAIN HOLE CLEARANCE**

**Service  
Notice**

**NOTICE No.:** 2100-7

**DATE:** 23 July 2015

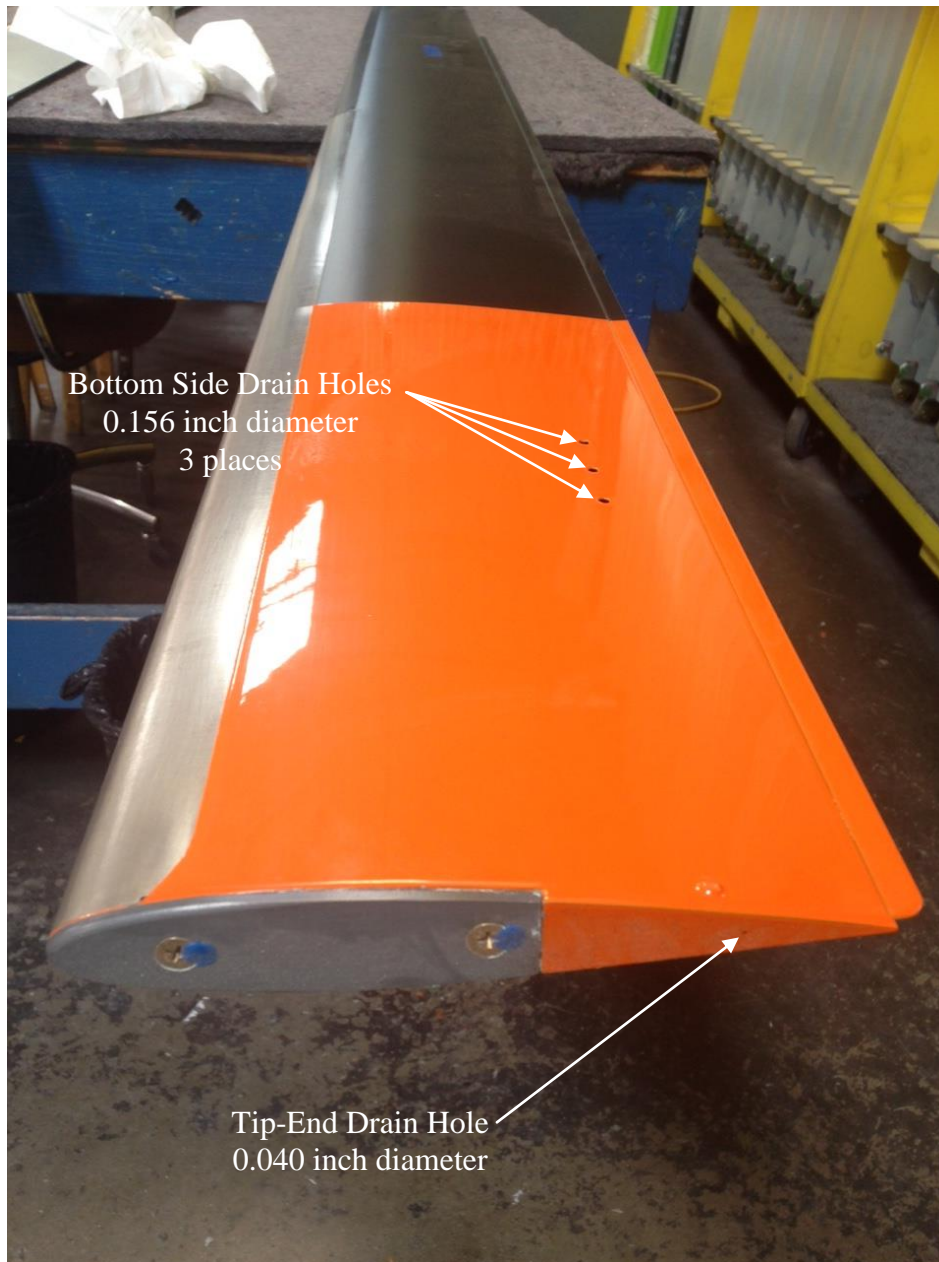
HTC has observed completely or partially blocked Drain Holes in the Tip-End on fielded Main Rotor Blades. Trapped water can cause a Failure of the Aft Tip Cap bond, Departure of the Aft Tip Cap in-flight, onset of significant vibration, and other significant damage to the internal structure of the Main Rotor Blade, including corrosion.

Figure 1 – Tip of Main Rotor Blade - Drain Holes (Bottom Side Shown)

- 1) Clean Tip-End area thoroughly with Solvent. Naphtha is recommended. MPK, MEK, or Acetone should not be used as they will remove the pigment from the paint. See Figure 1 above.
- 2) Visually Inspect areas to find evidence of Drain Hole Blockage. See Figure 1 above.
- 3) By hand, ensure that 5/32 Drill bit fits through each of the three (3) Bottom Side Drain Holes to a depth of 0.50 inch maximum. Do not nick far-side Blade Skin from inside with Drill Bit. See Figure 1 above.
- 4) If bare metal is exposed during the above step, touch-up paint as required.
- 5) By hand, ensure that #60 Drill bit fits through the Tip-End Drain Hole to a depth of 0.50 inch maximum. Do not nick far-side Blade Skin from inside with Drill Bit. See Figure 1 above.
- 6) No touch-up paint is required for the above step as it will likely re-block the Tip-End Drain Hole.
