**Mandatory
Service Bulletin**

TAIL ROTOR BLADE ABRASION STRIP TAP TEST AND MODIFICATION

Procedures in this service notice provide owners and operators with information pertaining to the periodic inspection of the abrasion strip to skin bond integrity on tail rotor blades.

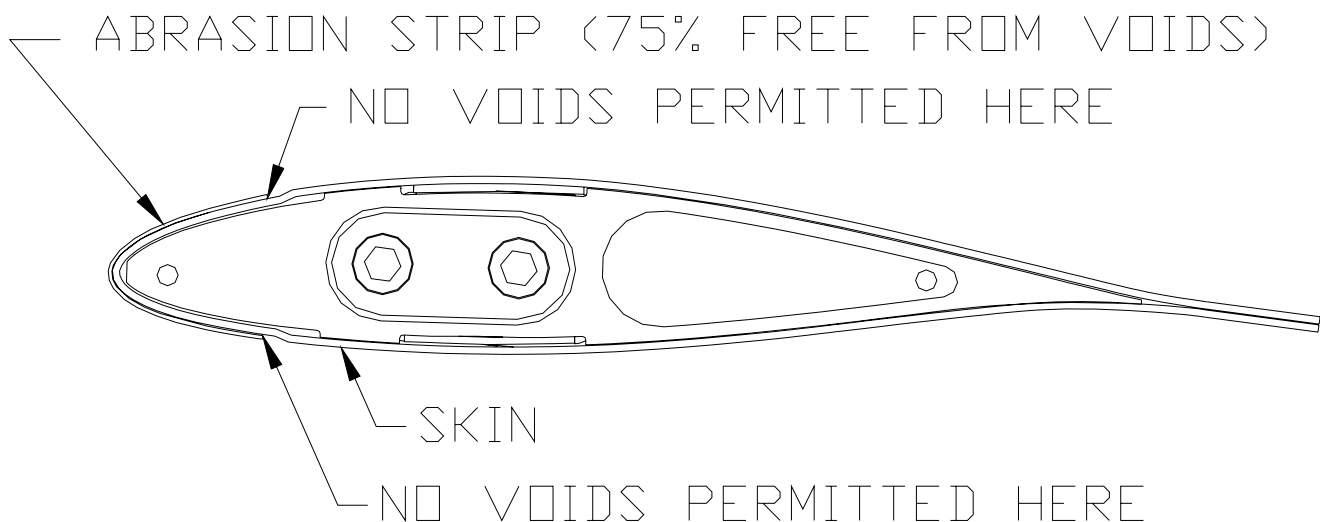
Physically perform a tap test on both the upper and lower surfaces of the abrasion strip surfaces on each tail rotor blade. Inspect the abrasion strip to skin bond from the inboard end of the blade to the blade tip in the spanwise direction and from the leading edge to the aft edge of the abrasion strip in the chordwise direction. The allowable void size in the abrasion strip area is 0.2 square inches. There shall be a minimum of 1.0 inches between voids in this area. 75% of the abrasion strip bonded area shall be free from voids except that no voids shall break out to the edges of the abrasion strip. The upper and lower surfaces shall be considered separately.

The tap inspection may be conducted using a coin (U.S. 25 cent piece or equivalent) or a small brass, steel, or aluminum hammer. Lightly tap the abrasion strip area as shown in the sketch below. A void will produce a tone change. The tone will be lower over the void. A method of “tuning” your ear is to tap from the leading edge of the blade towards the trailing edge. As you move pass the aft edge of the abrasion strip and over the unsupported skin, you will notice a distinctive lowering of the tone produced. Tap in a pattern with no more than 0.13 inches between taps in any direction.

Any blade that is outside of the above specification shall be replaced with an airworthy blade.
