TAIL ROTOR BLADE CONTROL ARM BUSHING SEALING

Procedures in this service notice provide owners and operators with information pertaining to application of Sealant in the areas surrounding the Control Arm Bushing in the Root Fitting.

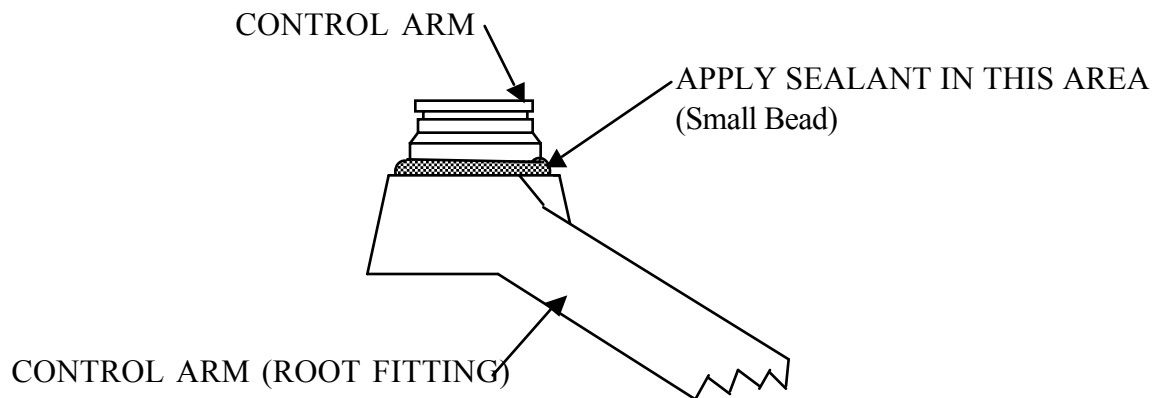
Figure 1 – Control Arm Area of Tail Rotor Blade Root Fitting

Failure to comply with this bulletin may result in corrosion around the Control Arm Busing in the Tail Rotor Root Fitting. Active Corrosion in this area could ultimately result in breakage of the Control Arm and loss of Tail Rotor and partial loss of directional control.

- 1) Clean area with Solvent.
- 2) Inspect area for Active Corrosion.
- 3) If the area does not have Sealant in place, apply small bead of Sealant to base of Control Arm Bushing as shown in Figure 1 below.
