**Mandatory
Service Bulletin**

**TAIL ROTOR BLADE PITCH CONTROL ARM CORROSION
INSPECTION**

Procedures in this service notice provide owners and operators with information pertaining to the periodic inspection of **Pitch Control Arms** on **Tail Rotor Blades**. **Pitch Control Arms** have been found with Corrosion that was not detected under the Paint.

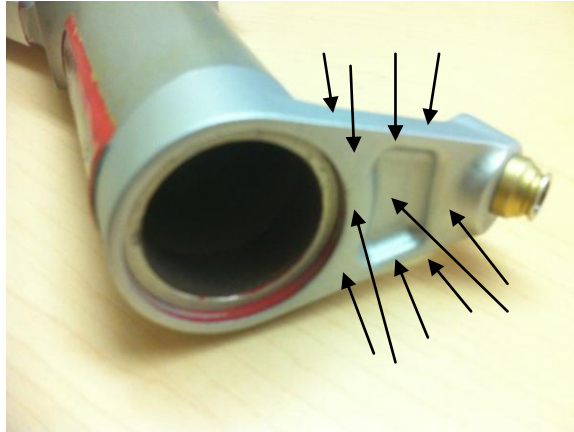
Figure 1 – Pitch Control Arm – Tail Rotor Blade

- 2. Inspection:** Using a **10x Magnifying Glass** and **Bright Light**, inspect all newly exposed surfaces of the **Pitch Control Arm – Tail Rotor Blade** on all affected Tail Rotor Blades (See **Figure 1**). Corrosion, Pitting, or Cracking is not permitted. Any evidence of Corrosion, Pitting, or Cracking renders the subject blade as **SCRAP**. Verify exposed areas have a “Dimpled” Shot Peen surface texture. Evidence of blending or material removal, which affect the Shot Peen surface appearance in the exposed areas, renders the subject blade as **SCRAP**. Verify in maintenance records that no rework has been done in this area.

- 1. Preparation for Inspection:** Remove affected Tail Rotor Blades from Helicopter. Mask Cross-Holes and Main Bore with **Aluminum Tape** to ensure **Paint Stripper** does not get inside blade. Remove Paint from front and back surfaces of the **Pitch Control Arm – Tail Rotor Blade** on affected Tail Rotor Blades using **Paint Stripper** on all affected Tail Rotor Blades (See **Figure 1**). Solvent wipe affected areas with **Isopropyl Alcohol** and **Clean Wipes**.

- 3. Re-Finish and Reinstallation:** Touch-up any exposed metallic surfaces with **Brush Alodine Solution**. Apply **Zinc Chromate Primer** and then apply **Top Coat Paint** over affected areas. Reinstall serviceable Tail Rotor Blades.
