TAIL ROTOR BLADE PITCH ARM CORROSION PROTECTION

The purpose of this notice is to minimize the potential for corrosion at the interface between the Pitch Link, Pitch Stud, and the Pitch Control Arm on each Tail Rotor Blade.

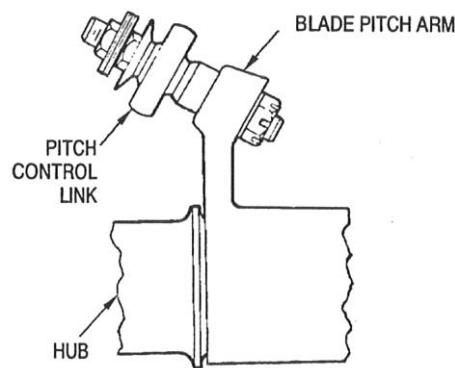
Figure 1 – Tail Rotor Blade Pitch Control Arm Area

Some operators have experienced persistent corrosion at the interface between the Pitch Link, Pitch Stud, and the Pitch Control Arm on each Tail Rotor Blade. This is accelerated by the presence of moisture in the environment, soot build-up on the tail rotor, and mechanical damage to the painted surfaces.

- 1) Upon installation of a Tail Rotor Blade or for a fielded Tail Rotor Blade Installation: Clean Blade Pitch Arm and Pitch Control Link areas (Figure 1) with Rubbing Alcohol and Q-Tips. Apply Corrosion Inhibiting Shellac to all exposed hardware shown in Figure 1 in the vicinity of the Blade Pitch Arm and Pitch Control Link, including the Pitch Stud, Castellated Nut, Washer, Pitch Arm Bushing, and Cotter Pin. Pay particular attention to any bare metal or removed paint on Blade Pitch Arm. This application should be performed after Dynamic Balance of Tail Rotor Assembly.

Note: Do not apply to Spherical Bearing in Pitch Control Link.

Note: Do not apply over active corrosion. Contact Helicopter Technology Company for Disposition.

Note: Do not attempt to rectify corrosion in this area in the field. Contact Helicopter Technology Company for Disposition.
