MAIN ROTOR BLADE TORQUE EVENT (TE) INSPECTION

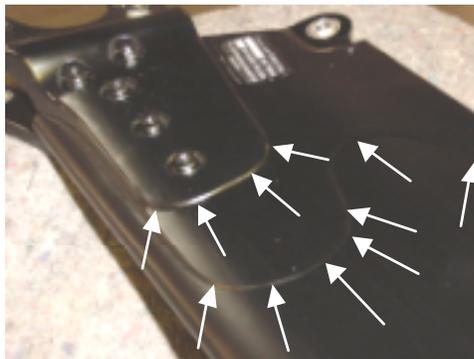
Figure 1 - Inboard Area of Main Rotor Blade - Bottom Side
